# Service Bulletin

Bulletin No: 36 001 01 (020) Revised

## BMW Motorcycles

### Recall 01V-198: Rear tire sidewall defect

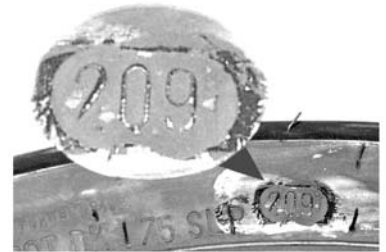
This campaign is limited to those Sportmax A rear tires having manufacturing date stamps of 189, 199, or 209.

Date stamps are found on the tire sidewall as shown.

**Concern:** It is possible that during production of the affected tires, areas of reduced adhesion on the tread reinforcing cushion strips may have resulted. During operation, this could lead to localized separations and blisters where the tread joins the sidewall. The affected area is above the 2-ply carcass. As a result, a sudden loss of air pressure due to this problem is not likely to occur.

**Service Measures:** The rear tire of each affected motorcycle is to be inspected. If a tire of the affected make, model and date range of manufacture is found to be in use, it is to be replaced.

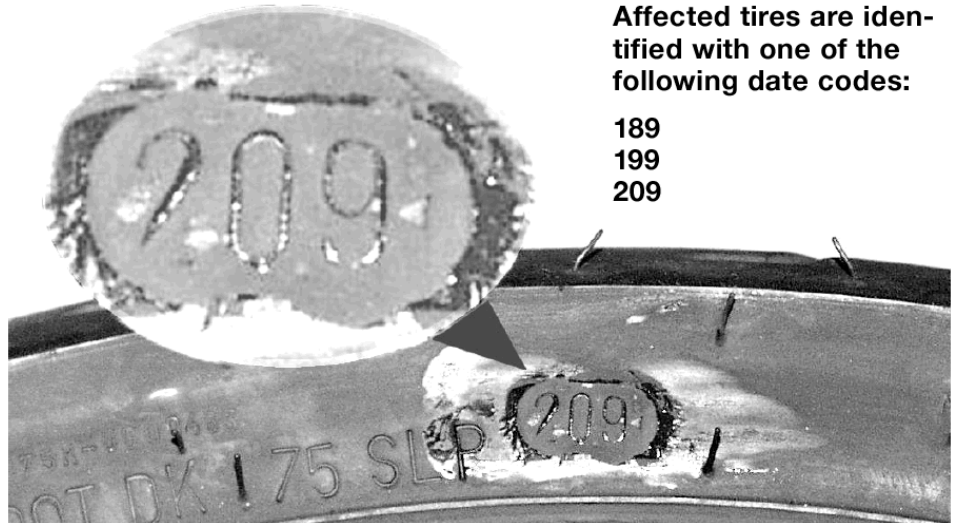
The photo below illustrates the location on the side wall and the general appearance of the manufacturing date stamp that will need to be checked on all motorcycles affected by this recall.

**Affected tires are identified with one of the following date codes:**

- 189**
- 199**
- 209**

Replacement tires are available through normal BMW NA parts distribution channels using BMW part number 99 00 0 001 123.
