Service-Information Motorcycle

Group: 34
Brakes

August 1991
34 025 91
(2467)

Brake Pipe Recall #91V-107 – R80RT, R100RT, R100RS

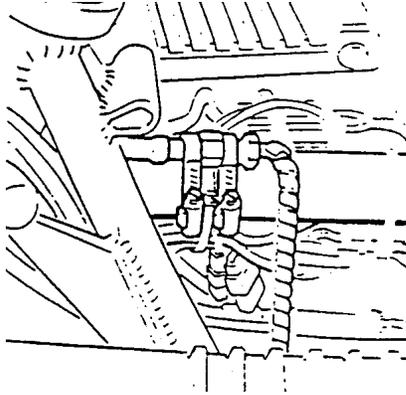
Problem: The brake pipe which is under the gas tank on the left side of the frame may chafe on the inside gas tank surface, or chafe on the speedometer cable.

3. The brake pipe must be secured with an additional hose clamp and support, so that its position cannot change.

To make the assembly easier, remove the cable tie, which secures the wiring harness to the frame tube. Replace this cable tie after the brake pipe is in place and secured.
