Service-Information Motorcycle

Fuel Tank
and Lines

16 016 91
(2486)

Fuel Cap - All Boxer Models

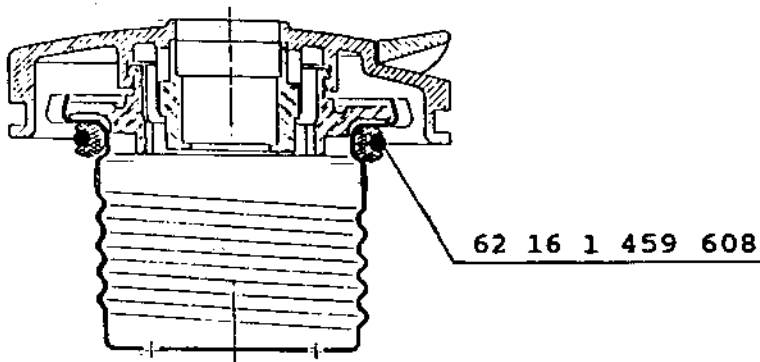
- Condition:** The fuel cap chafes the painted surface of the tank at the filler neck.
- Cause:** The filler neck is welded too deeply into the fuel tank.
- Remedy:** Install an O-ring - part no. 62 16 1 459 608 - into the groove of the fuel cap seal. The O-ring makes the seal slightly thicker and the cap cannot be screwed in as far.

Please check new motorcycles for appropriate fuel cap fit.
