Service-Information Motorcycle

Group: 32
Steering

November 1994
32 008 94
(2655)

Recall 94V-233 Steering

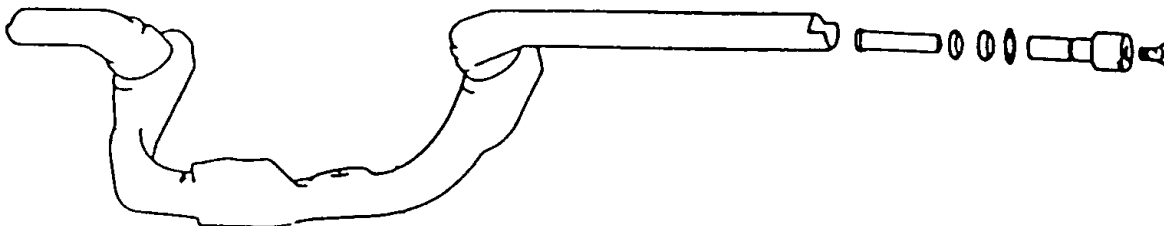
Fig. #1

Problem: Potential defect #1 involves the possible cracking of the left and/or right handle bar. In extreme cases (as in hard use on bumpy surfaces) the handle bar could break. Potential defect #2, the ball joint nut on the Telelever could loosen.

Repair #1: Replace the handle bars left and right

Hint: Loosen the screw in the handle bar weight and spray Loctite #7070 in the end of the bar to get the o-rings to loosen up - push in then pull them out.

Kit part number	32 71 2 331 035
Handle bar bolt torque	20 Nm (14 Ft LB) use Loctite #243
Bar end weight torque	20 Nm (14 Ft LB)
