Service-Information Motorcycle

Group: 61
General
Electrics

April, 1988
61 017 88
(2305)

Brake Light Switch - Part No. 61 31 1 459 569 - R & K Models

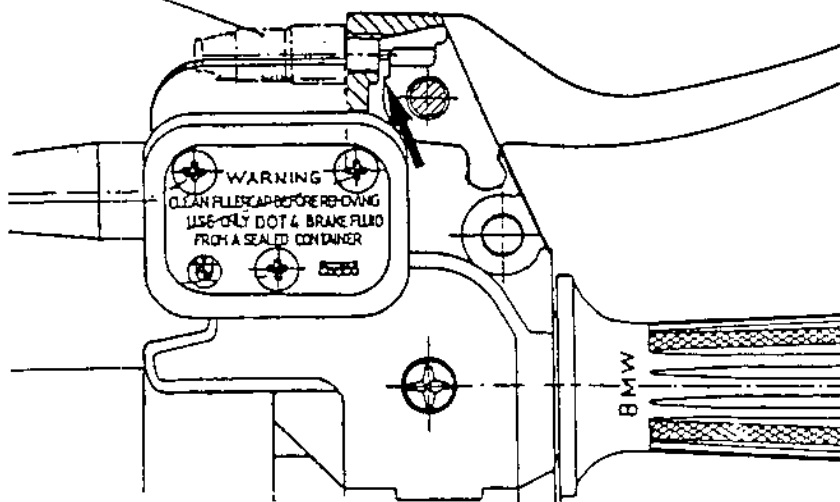
Brake light switch

Problem: The small plastic pin which actuates the brake light switch becomes bent, causing the switch to fail.

- Cause:**
- Front Brake Light Switch: The plastic pin is bent by the hand brake lever. See the point of contact in the drawing below.
 - Rear Brake Light Switch: The stop bolt which actuates the switch may contact the plastic pin at an angle, causing the pin to form a ridge or burr.
- Remedy:**
- Hand Brake Lever: Remove the lever and file or belt-sand the milled cutout on the hand brake lever until the plastic pin no longer catches the sharp corner.
