Service-Information Motorcycle

Group: 52
Dual Seat

August, 1988
52 006 88
(2321)

Dual Seat Locating Arm - R100GS

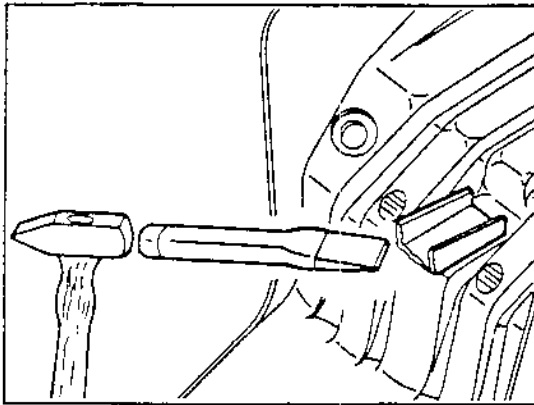
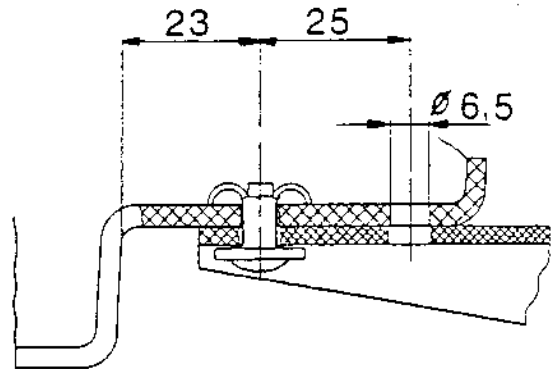
Complaint: Locating Arm breaks off

Cause: The method of attaching the Locating Arm (by hot glueing) causes the plastic arm to become brittle. If the seat is incorrectly installed (the plastic arm lying on top of the frame tube instead of into it), it can break under the rider's weight.

Remedy: Production motorcycles no longer have the glued-on arm. The arm is now bolted to the seat base. Remove the remaining part of the arm, using a chisel as shown below. Drill two 6.5mm holes in the seat base and install the parts contained in Repair Kit 52 53 2 307 170. See line drawing below for measurements:
