Service-Information Motorcycle

Group: 31
Front Forks

September, 1988
31 023 88
(2326)

Noisy Upper Fork Spring Support - '85 R65, R80, R100 Models

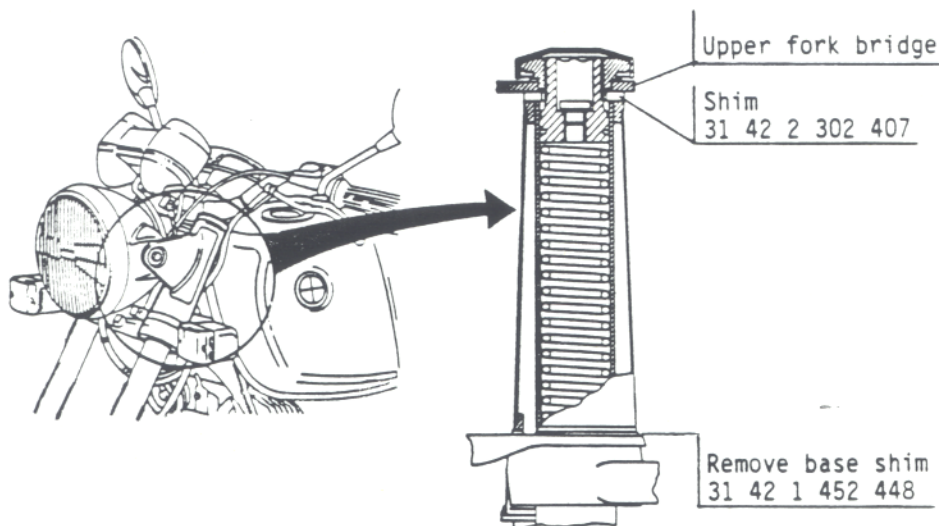
Problem: The fork spring support nut might work loose at the top fork bridge, causing an audible rattle.

Cause: The fork tube radius is pressing into the top fork bridge.

Remedy: Should this condition occur, install a shim:

Part no. 31 42 2 302 407

between the fork tube and top fork bridge to prevent the tubes from pressing into the casting.

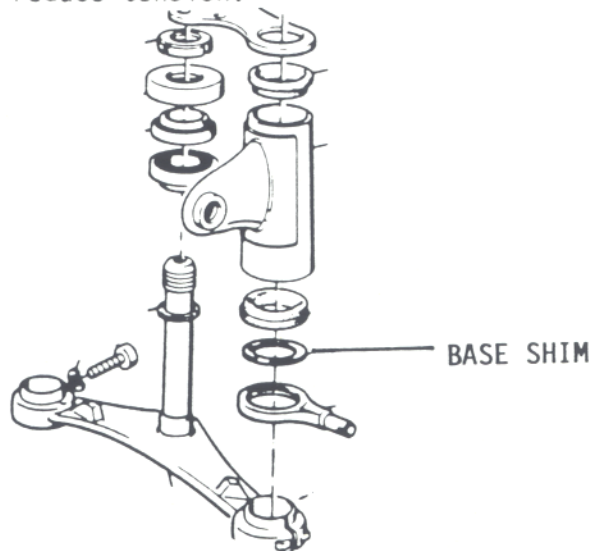
The headlight holders on the basic R65 and R80 are secured between the upper and lower bridge with rubber rings. A base shim - part no. 31 42 1 452 448 - must be removed to reduce tension.
