Service-Information Motorcycle

©BMW of N.A. Service Department	Group: 13 Fuel Supply & Adjustment	August 1990 13 020 90 (2414)	For USA Only
------------------------------------	--	------------------------------------	--------------

Carburetor Vibration - 1988 R100

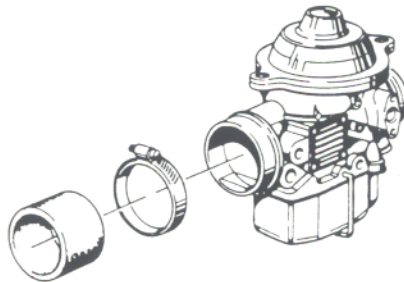
- Complaint:** Presence of fuel stains on the outside of the carburetor and float bowl. This could occur when engine is running at certain higher rpm's.
- Problem:** The carburetor can vibrate at certain speeds (usually high-speed), causing an increase in the fuel level in the float bowl.
- Remedy:** First, ensure that float bowl gasket is in good condition, that no contaminants are present in float bowl, and that fuel level is to specification. If the items mentioned above are all correct, then install carburetor mounting rubber tubes #13 72 1 254 654 in place of the stock tubes #13 72 1 338 360. These tubes have a different rubber density which will reduce carburetor vibration.
