Service-Information Motorcycle

Rear Wheel

33 017 92 (2506) For USA Only

Rear Shock Adjustment Knob Numbering - R100GS 1991 Models

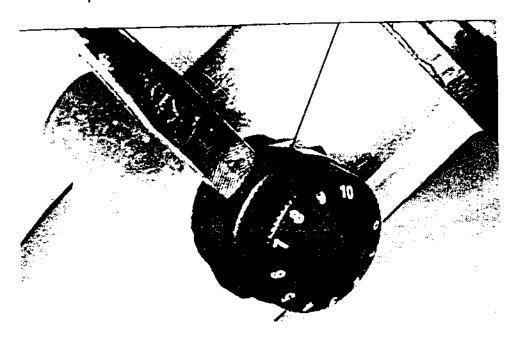
The white numbers on the rear shock adjusting knob

have a tendency to come off.

Using a center punch, put a mark on the plastic nut which is below the knob

- Pry the knob off gently, using a screwdriver
- Using a plastic hammer, drive the new adjusting knob on with the Figure 10 aligned with your center punch mark:
