Service-Information Motorcycle

©BMW of N.A. Service Department	Group: 61 General Electrics	August, 1992 61 027 92 (2548)	For USA Only
------------------------------------	--------------------------------------	-------------------------------------	--------------

Additional Ground Between Engine and Frame - R100R Models

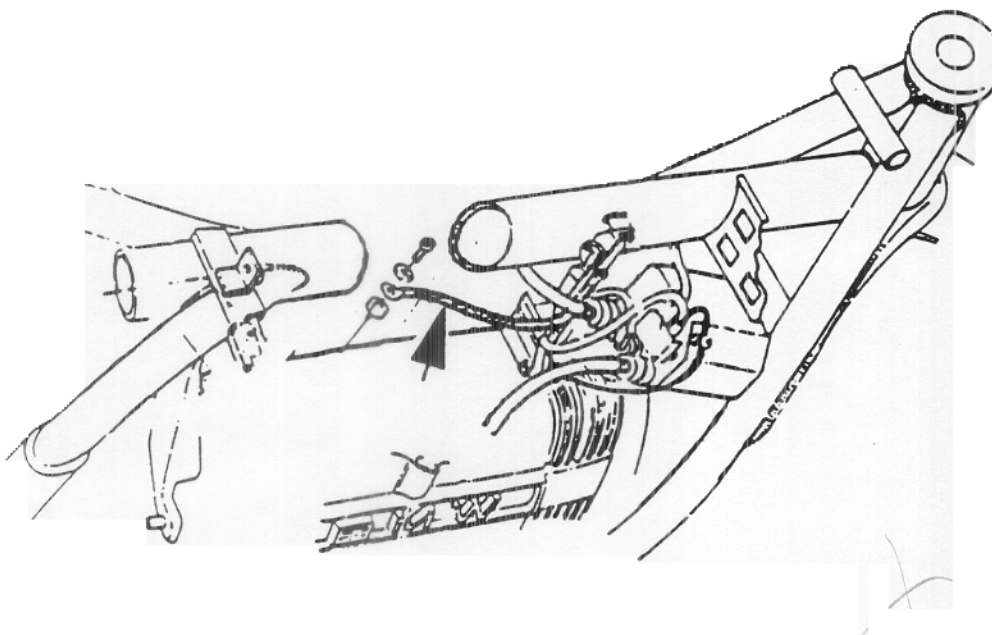
Problem: Grounding between the engine and frame is not always reliable on silver-painted frames. This may lead to ignition misfiring or insufficient alternator output.

Remedy: Install a ground wire to all affected R100R models with a VIN prior to 0280227.

The ground wire is secured to the left starter motor cover screw and the ignition control unit mounting bracket.
